Ten Lessons Learned About Host Nation Construction in Afghanistan

Mittal, V., PhD. (2016). Ten lessons learned about host-nation construction in Afghanistan. *Military Review*, 96(5), 94-101.

Ten Lessons Learned about Host-Nation Construction in Afghanistan

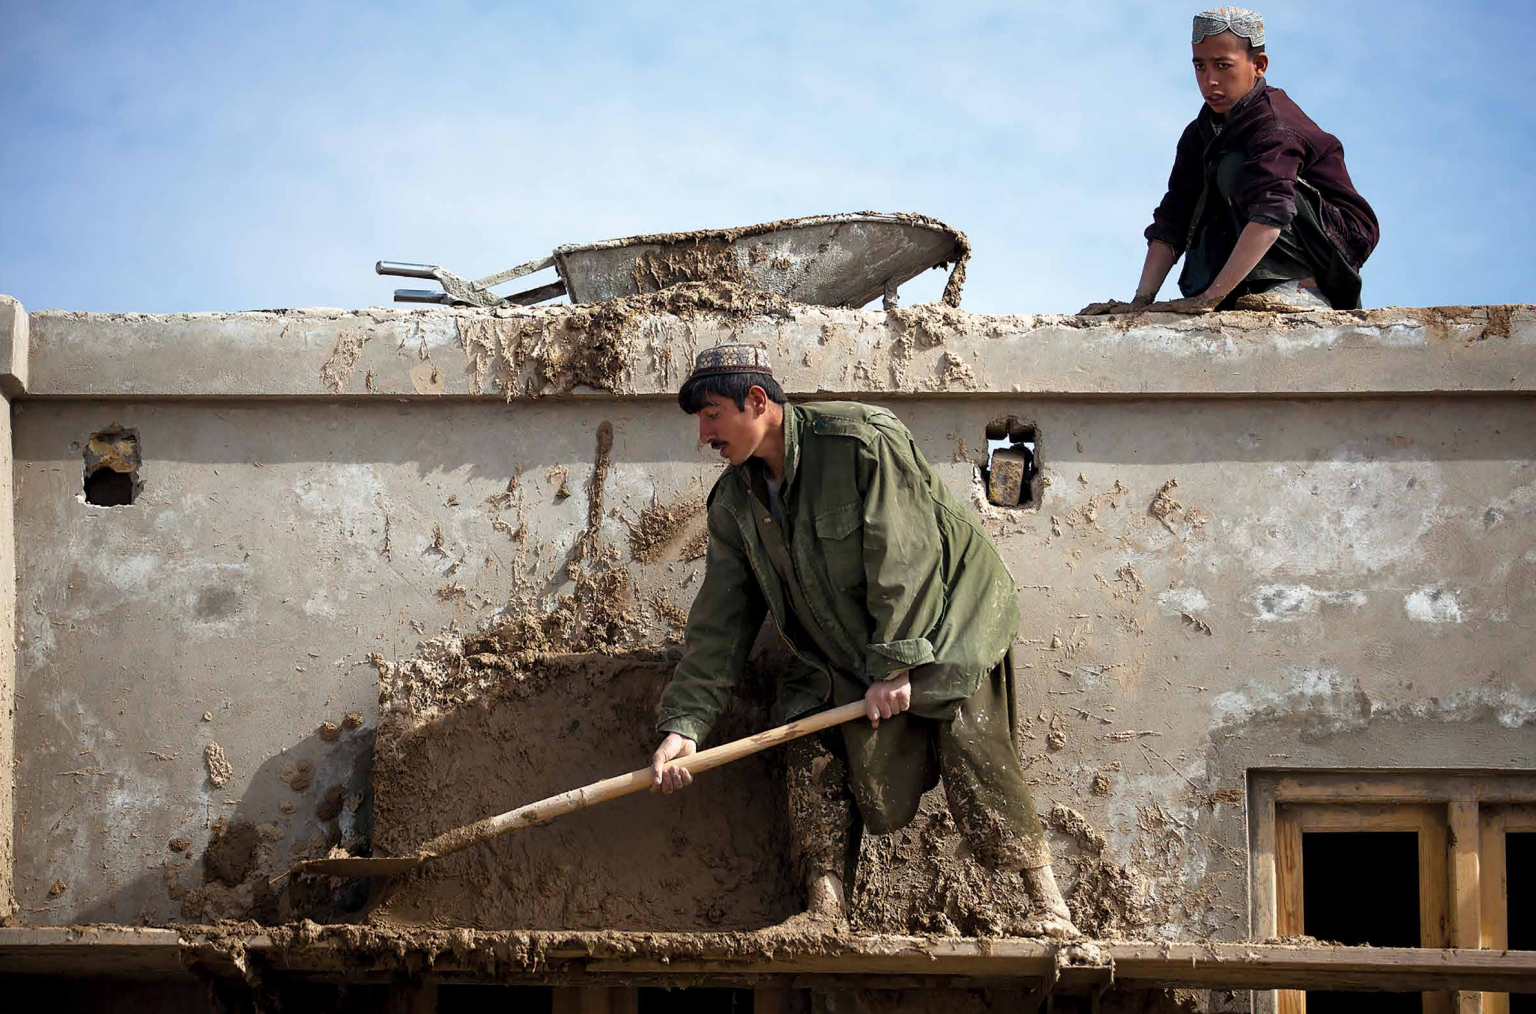
Afghan contractors reinforce the roof of a school under construction 19 January 2012 in Garmsir District, Helmand Province, Afghanistan. Twelve permanent schools were under construction by Afghan contractors in the Garmsir District. A civil affairs team in support of the 3rd Battalion, 3rd Marine Regiment, visited several of the sites to inspect the structures and ensure compliance with the quality assurance standards of the Afghan government. (Photo by Cpl. Reece Lodder, U.S. Marine Corps)
